**Flood Control Project Maintenance
Levee Inspections**
LMA District Cover Sheet
Spring 2019 Levee Inspection Results

Reclamation District No. 2060 Hastings

Spring 2019 Levee Inspection Results

Waterway	Bank	Unit Miles
Unit No. 01 Lindsey Slough	Left	6.97

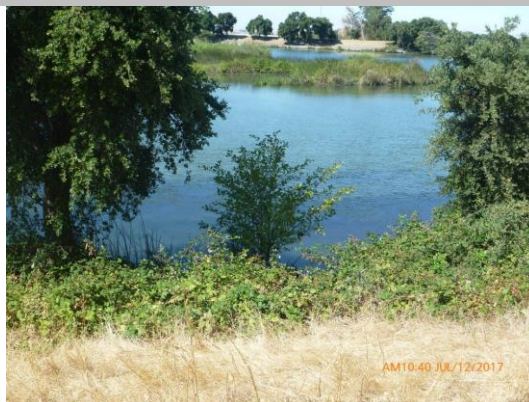
Photo 4 of 6 : SP_2019_RD2060_241_5_20190311_00004.jpg

LM Start	0.40	Rating **	M	Issue No.	5 (cont)	
LM End	0.40	Issue Type +	Ma	Location *	WS	
Category	Supplemental			GPS Latitude/Longitude		
				Start		End
Item	2017 Storm Damage			38.247894 °		38.247911 °
				-121.703492 °		-121.703539 °
DWR ID	DWR_RD2060_01_f _ 2017_5					
Comment Code						
Inspector Comment						
Levee Evaluation Comments						
Description:Erosion commences approximately 3/4 of the way down the slope, near the water line towards the waterside toe.						
Site ID No:358						
Site Designation:LMA-185						
Repair Type: Erosion						
Rating:Area of Concern						
Field Date:7/12/2017						
Notes: Small erosion into bank.

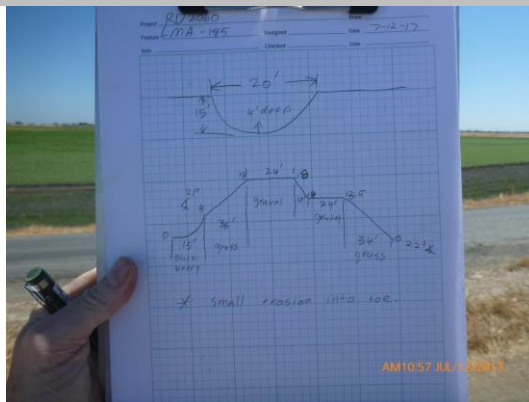
Photo 6 of 6 : SP_2019_RD2060_241_5_20190311_00006.jpg

LM Start	0.40	Rating **	M	Issue No.	5 (cont)	
LM End	0.40	Issue Type +	Ma	Location *	WS	
Category	Supplemental			GPS Latitude/Longitude		
				Start		End
Item	2017 Storm Damage			38.247894 °		38.247911 °
				-121.703492 °		-121.703539 °
DWR ID	DWR_RD2060_01_f _ 2017_5					
Comment Code						
Inspector Comment						
Levee Evaluation Comments						
Description:Erosion commences approximately 3/4 of the way down the slope, near the water line towards the waterside toe.						
Site ID No:358						
Site Designation:LMA-185						
Repair Type: Erosion						
Rating:Area of Concern						
Field Date:7/12/2017						
Notes: Small erosion into bank.

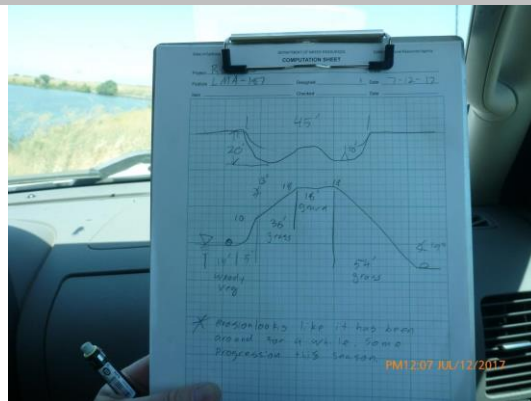
Photo 3 of 3 : SP_2019_RD2060_241_9_20190311_00012.jpg

LM Start	0.75	Rating **	M	Issue No.	9 (cont)
LM End	0.76	Issue Type +	Ma	Location *	WS
Category	Supplemental		GPS Latitude/Longitude		
			Start	End	
Item	2017 Storm Damage		38.249314 °	38.249400 °	
			-121.709461 °	-121.709608 °	
DWR ID	DWR_RD2060_01_f_2017_9				
Comment Code					
Inspector Comment					
<p>Levee Evaluation Comments</p> <p>Description: Erosion commences approximately halfway down the water side slope extending in to existing rip rap. Erosion is concentrated near the waterline. Existing rip rap appears to have been pulled off in this section.</p> <p>Site ID No: 360</p> <p>Site Designation: LMA-187</p> <p>Repair Type: Erosion</p> <p>Rating: Area of Concern</p> <p>Field Date: 7/12/2017</p> <p>Notes: Erosion looks old but has progressed this year.</p>

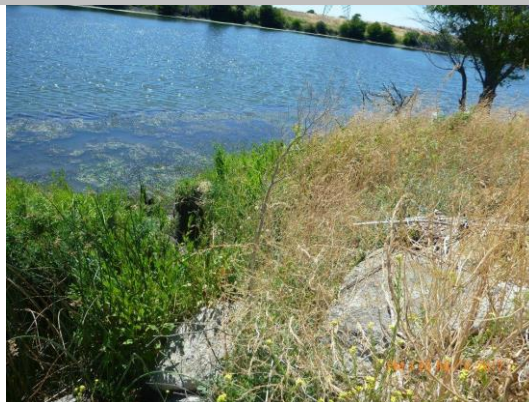
Photo 2 of 3 : SP_2019_RD2060_241_21_20190311_00027.jpg

LM Start	1.81	Rating **	A/W	Issue No.	21
LM End	1.84	Issue Type +	Ma	Location *	WS
Category	Supplemental			GPS Latitude/Longitude	
				Start	End
Item	2017 Storm Damage			38.255972 °	38.256247 °
				-121.724197 °	-121.724464 °
DWR ID	DWR_RD2060_01 f _ 2017_21

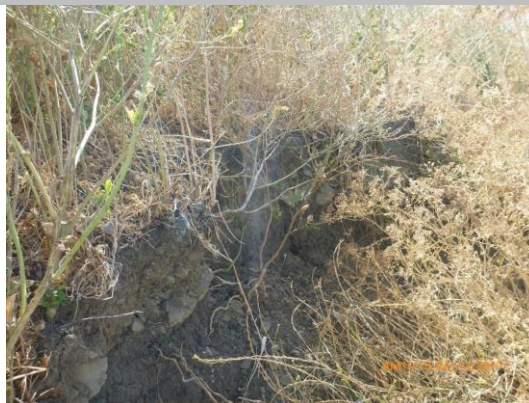
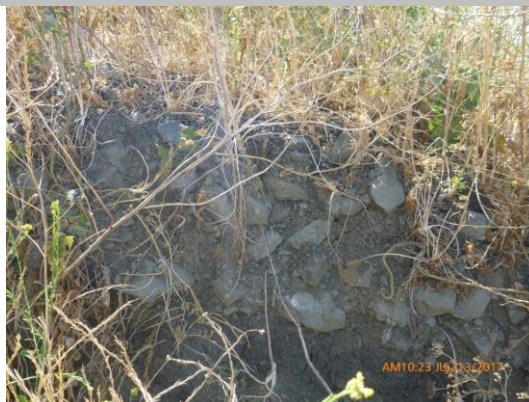
LM Start	2.10	Rating **	A/W	Issue No.	23
LM End	2.13	Issue Type +	Ma	Location *	
Category	Supplemental			GPS Latitude/Longitude	
				Start	End
Item	2017 Storm Damage			38.259317 °	38.259258 °
				-121.726314 °	-121.726939 °
DWR ID	DWR_RD2060_01_f _ 2017_23				
Comment Code					
Inspector Comment					
Levee Evaluation Comments					
Description:Erosion commences approximately halfway down the water side slope extending to the rip rap.					
Site ID No:368					
Site Designation:LMA-195					
Repair Type: Erosion					
Rating:Serious					
Field Date:7/13/2017					
Notes: Erosion appears to be previously repaired, but has failed again.

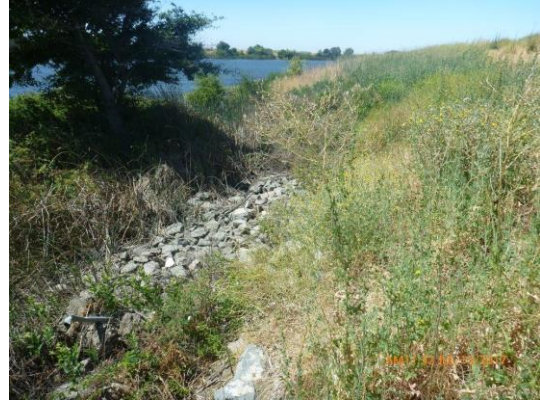
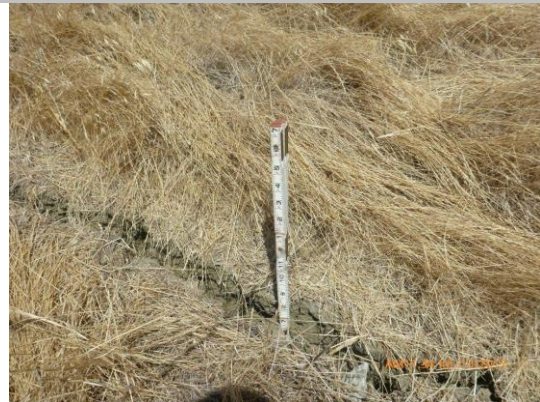
LM Start	3.07	Rating **	A/W	Issue No.	25
LM End	3.10	Issue Type +	Ma	Location *	
Category	Supplemental			GPS Latitude/Longitude	
				Start	End
Item	2017 Storm Damage			38.260772 °	38.260569 °
				-121.740817 °	-121.741194 °
DWR ID	DWR_RD2060_01_f_2017_25				
Comment Code					
Inspector Comment					
Levee Evaluation Comments					
Description:Erosion occurs near the waterline. Part of the levee has sloughed down toward the waterline due to erosion.					
Site ID No:370					
Site Designation:LMA-197					
Repair Type: Erosion					
Rating:Serious					
Field Date:7/13/2017					
Notes: Large erosion halfway into levee. Horizontal cracking on slope almost 24"deep.

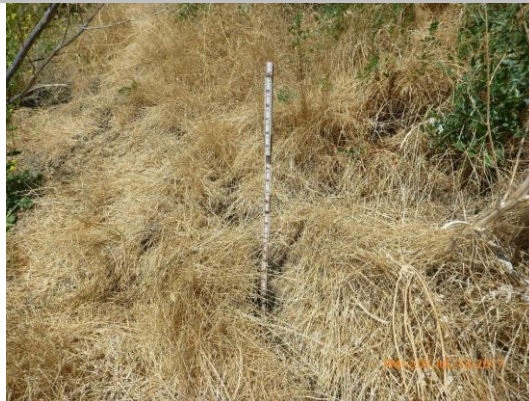
LM Start	3.17	Rating **	M	Issue No.	26 (cont)	
LM End	3.17	Issue Type +	Ma	Location *		
Category	Supplemental			GPS Latitude/Longitude		
				Start		End
Item	2017 Storm Damage			38.259925 °	38.259903 °	
				-121.742236 °	-121.742281 °	
DWR ID	DWR_RD2060_01_f_2017_26					
Comment Code						
Inspector Comment						
Levee Evaluation Comments Description:Erosion occurs near the waterline. Site ID No:371 Site Designation:LMA-198 Repair Type: Erosion Rating:Area of Concern Field Date:7/13/2017 Notes: Minor erosion with sloughing. Horizontal cracks 3.5' deep.

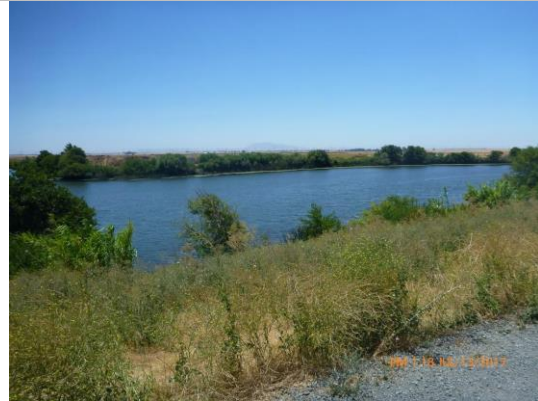
Photo 3 of 3 : SP_2019_RD2060_241_27_20190311_00046.jpg

LM Start	3.60	Rating **	M	Issue No.	27 (cont)
LM End	3.61	Issue Type +	Ma	Location *	
Category	Supplemental			GPS Latitude/Longitude	
				Start	End
Item	2017 Storm Damage			38.261469 °	38.261464 °
				-121.748389 °	-121.748442 °
DWR ID	DWR_RD2060_01_f_2017_27				
Comment Code					
Inspector Comment					
Levee Evaluation Comments					
Description:Erosion commences halfway down the slope and extends to the toe. Erosion is concentrated at the water line.					
Site ID No:373					
Site Designation:LMA-200					
Repair Type: Erosion					
Rating:Area of Concern					
Field Date:7/13/2017					
Notes: Small erosion with a narrow deep cut. Heavy veg is protecting the slope.

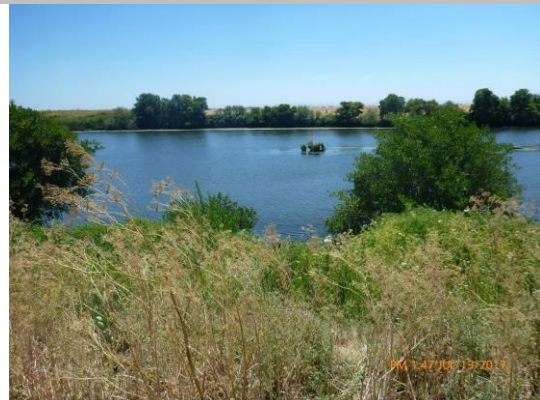
Photo 1 of 3 : SP_2019_RD2060_241_28_20190311_00047.jpg

LM Start	3.67	Rating **	M	Issue No.	28
LM End	3.67	Issue Type +	Ma	Location *	
Category	Supplemental			GPS Latitude/Longitude	
				Start	End
Item	2017 Storm Damage			38.261181 °	38.261167 °
				-121.749542 °	-121.749592 °
DWR ID	DWR_RD2060_01_f_2017_28				
Comment Code					
Inspector Comment					
Levee Evaluation Comments					
Description:Erosion is concentrated near the water line.					
Site ID No:374					
Site Designation:LMA-201					
Repair Type: Erosion					
Rating:Area of Concern					
Field Date:7/13/2017					
Notes: Small narrow and deep cut. May have been caused by a collapsed beaver den.

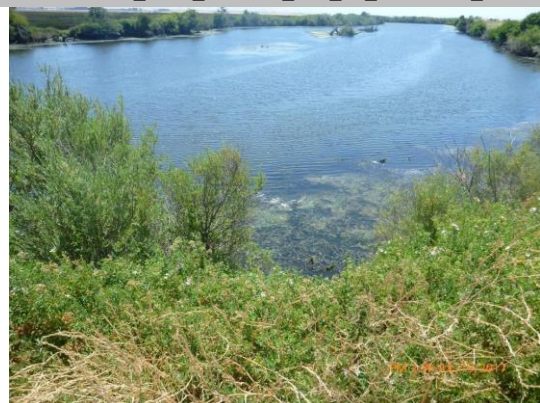
Photo 1 of 3 : SP_2019_RD2060_241_29_20190311_00050.jpg

LM Start	4.28	Rating **	A/W	Issue No.	29
LM End	4.28	Issue Type +	Ma	Location *	
Category	Supplemental			GPS Latitude/Longitude	
				Start	End
Item	2017 Storm Damage			38.260992 °	38.261017 °
				-121.759806 °	-121.759847 °
DWR ID	DWR_RD2060_01_f_2017_29				
Comment Code					
Inspector Comment					
Levee Evaluation Comments					
Description:Erosion commences halfway down the slope and extends to the toe. Erosion is concentrated at the water line.					
Site ID No:376					
Site Designation:LMA-203					
Repair Type: Erosion					
Rating:Area of Concern					
Field Date:7/13/2017					
Notes: Could not get to erosion due to dense veg. Possibly a deep narrow cut.

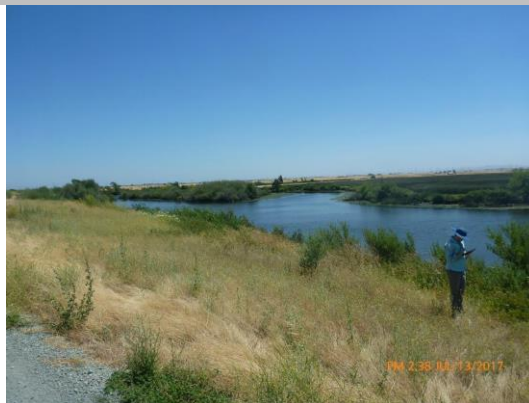
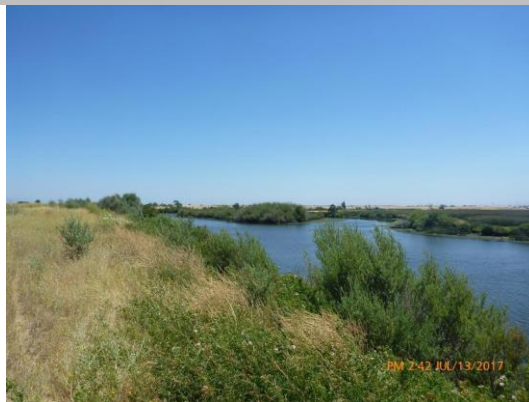
LM Start	4.28	Rating **	A/W	Issue No.	29 (cont)
LM End	4.28	Issue Type +	Ma	Location *	
Category	Supplemental			GPS Latitude/Longitude	
				Start	End
Item	2017 Storm Damage			38.260992 °	38.261017 °
				-121.759806 °	-121.759847 °
DWR ID	DWR_RD2060_01_f_2017_29				
Comment Code					
Inspector Comment					
Levee Evaluation Comments					
Description:Erosion commences halfway down the slope and extends to the toe. Erosion is concentrated at the water line.					
Site ID No:376					
Site Designation:LMA-203					
Repair Type: Erosion					
Rating:Area of Concern					
Field Date:7/13/2017					
Notes: Could not get to erosion due to dense veg. Possibly a deep narrow cut.

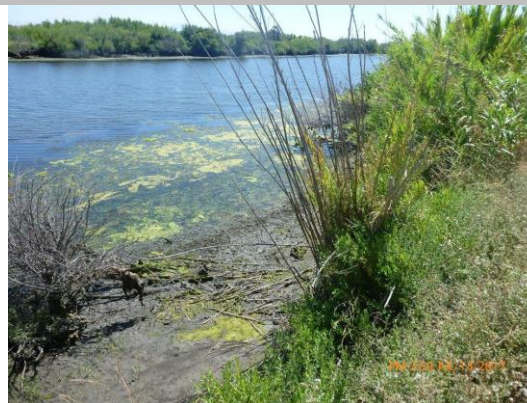
Photo 1 of 3 : SP_2019_RD2060_241_30_20190311_00053.jpg

LM Start	4.40	Rating **	M	Issue No.	30
LM End	4.46	Issue Type +	Ma	Location *	
Category	Supplemental			GPS Latitude/Longitude	
				Start	End
Item	2017 Storm Damage			38.260850 °	38.260425 °
				-121.761875 °	-121.762861 °
DWR ID	DWR_RD2060_01_f_2017_30				
Comment Code					
Inspector Comment					
Levee Evaluation Comments					
Description:Erosion/sloughing commences approximately halfway down the slope. Erosion is concentrated mostly near the water line and has resulting in slippage of the slope.					
Site ID No:377					
Site Designation:LMA-204					
Repair Type: Erosion					
Rating:Area of Concern					
Field Date:7/13/2017					
Notes: large cut is 100' of 320' site. Large cut is 12' vertical and the rest is 6'.

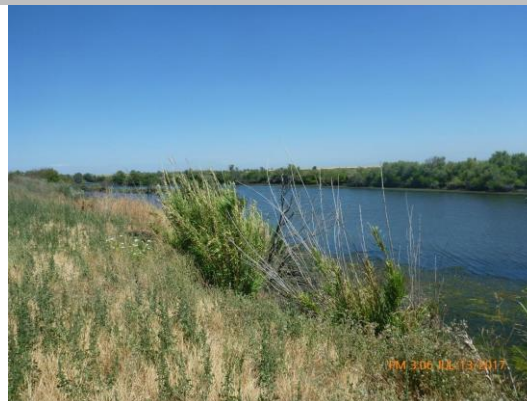
Photo 2 of 3 : SP_2019_RD2060_241_30_20190311_00054.jpg

LM Start	4.40	Rating **	M	Issue No.	30 (cont)
LM End	4.46	Issue Type +	Ma	Location *

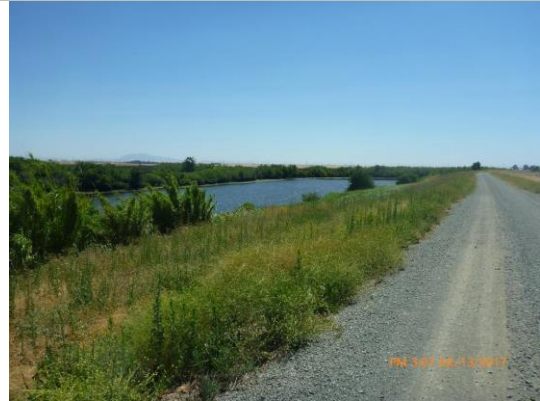
Photo 3 of 3 : SP_2019_RD2060_241_30_20190311_00055.jpg

LM Start	4.40	Rating **	M	Issue No.	30 (cont)	
LM End	4.46	Issue Type +	Ma	Location *		
Category	Supplemental			GPS Latitude/Longitude		
				Start	End	
Item	2017 Storm Damage			38.260850 °	38.260425 °	
				-121.761875 °	-121.762861 °	
DWR ID	DWR_RD2060_01_f_2017_30					
Comment Code						
Inspector Comment						
Levee Evaluation Comments Description:Erosion/sloughing commences approximately halfway down the slope. Erosion is concentrated mostly near the water line and has resulting in slippage of the slope. Site ID No:377 Site Designation:LMA-204 Repair Type: Erosion Rating:Area of Concern Field Date:7/13/2017 Notes: large cut is 100' of 320' site. Large cut is 12' vertical and the rest is 6'.

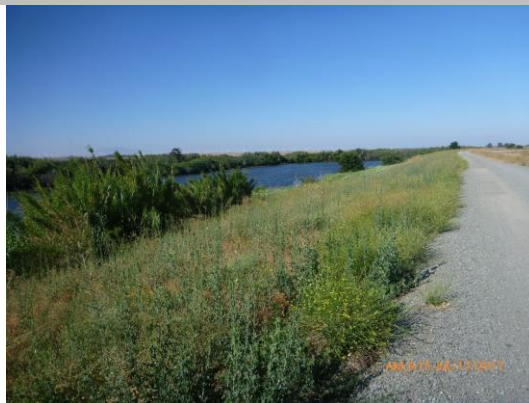
Photo 3 of 3 : SP_2019_RD2060_241_31_20190311_00058.jpg

LM Start	4.50	Rating **	A/W	Issue No.	31 (cont)
LM End	4.53	Issue Type +	Ma	Location *	
Category	Supplemental			GPS Latitude/Longitude	
				Start	End
Item	2017 Storm Damage			38.260150 °	38.259939 °
				-121.763556 °	-121.764064 °
DWR ID	DWR_RD2060_01_f_2017_31				
Comment Code					
Inspector Comment					
Levee Evaluation Comments					
Description:Erosion commences approximately 3/4 of the way down the slope. It has resulted in some sloughing.					
Site ID No:378					
Site Designation:LMA-205					
Repair Type: Erosion					
Rating:Serious					
Field Date:7/17/2017					
Notes: Deep, wide, vertical cut into slope almost 1/2 way into sope.

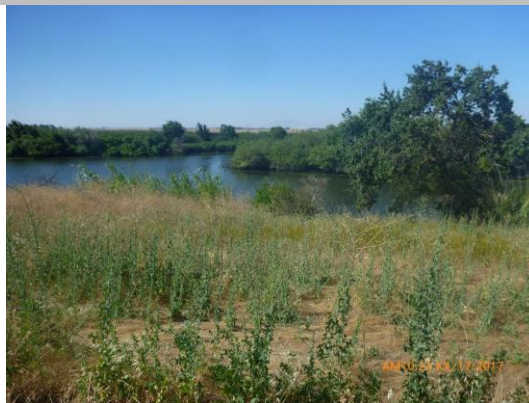
Photo 3 of 3 : SP_2019_RD2060_241_33_20190311_00064.jpg

LM Start	4.92	Rating **	M	Issue No.	33 (cont)	
LM End	4.92	Issue Type +	Ma	Location *		
Category	Supplemental			GPS Latitude/Longitude		
				Start	End	
Item	2017 Storm Damage			38.262128 °	38.262128 °	
				-121.769175 °	-121.769175 °	
DWR ID	DWR_RD2060_01_f_2017_33					
Comment Code						
Inspector Comment						
Levee Evaluation Comments						
Description:Erosion/sloughing commences approximately halfway down the slope. Erosion is concentrated mostly near the water line and has resulting in slippage of the slope into the toe.						
Site ID No:380						
Site Designation:LMA-207						
Repair Type: Erosion						
Rating:Area of Concern						
Field Date:7/17/2017						
Notes: Reduced length of site from 275 to 62. No widespread erosion, just 2 small erosions upstream from adjacent riprap.

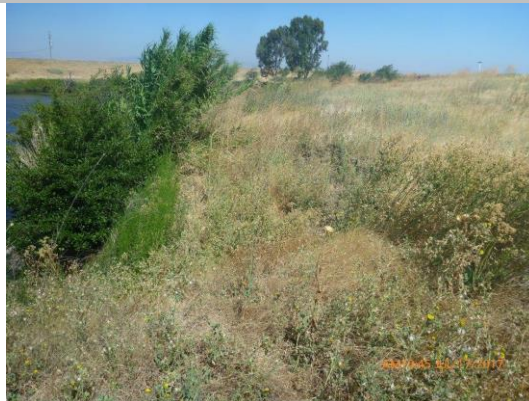
LM Start	5.00	Rating **	M	Issue No.	34 (cont)	
LM End	5.01	Issue Type +	Ma	Location *		
Category	Supplemental			GPS Latitude/Longitude		
				Start	End	
Item	2017 Storm Damage			38.262636 °	38.262658 °	
				-121.770503 °	-121.770547 °	
DWR ID	DWR_RD2060_01_f_2017_34					
Comment Code						
Inspector Comment						
Levee Evaluation Comments						
Description:Erosion is concentrated mostly near the water line and has resulting in slippage of the slope into the toe.						
Site ID No:381						
Site Designation:LMA-208						
Repair Type: Erosion						
Rating:Area of Concern						
Field Date:7/17/2017						
Notes: Extended site from 15' to 75' to include LMA-209. Small erosions will become 1 site next high water due to sloughing between them.

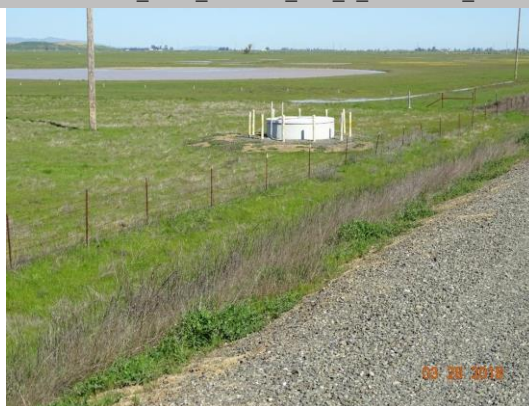
Photo 1 of 1 : SP_2019_RD2060_242_2_20190311_00001.jpg

LM Start	0.12	Rating **	M	Issue No.	2
LM End	1.78	Issue Type +	En	Location *	WS
Category	Earthen Levee			GPS Latitude/Longitude	
				Start	End
Item	Encroachments			38.276351 °	38.285819 °
				-121.795922 °	-121.776942 °
DWR ID	DWR_RD2060_02_s_2017_2				
Comment Code					
FE : Fence					
Inspector Comment					
This fence has no permit.

Barbed wire fence on waterside has no permit.

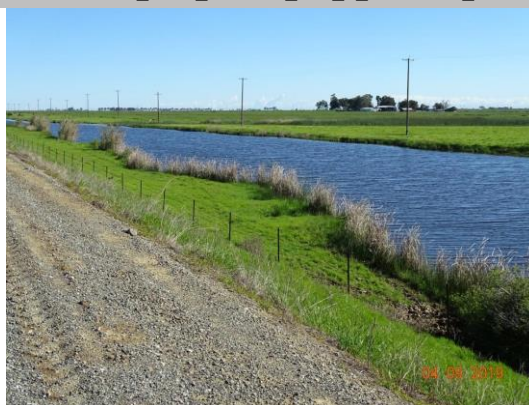
Photo 1 of 1 : SP_2019_RD2060_242_5_20190409_00012.jpg

LM Start	0.14	Rating **	M	Issue No.	5
LM End	1.74	Issue Type +	En	Location *	LS
Category	Earthen Levee			GPS Latitude/Longitude	
				Start	End
Item	Encroachments			38.276614 °	38.285270 °
				-121.795990 °	-121.777076 °
DWR ID	DWR_RD2060_02_s_2019_5				
Comment Code					
FE : Fence					
Inspector Comment					
Fence has no permit

View looking upstream at fence at the landside toe (Spring 2019).

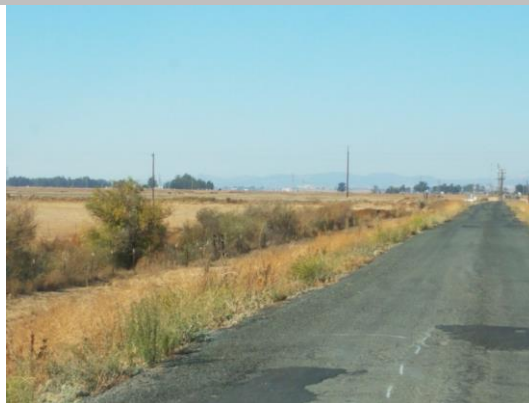
Photo 1 of 1 : SP_2019_RD2060_242_6_20190311_00002.jpg

LM Start	0.74	Rating **	M	Issue No.	6
LM End	1.73	Issue Type +	Ma	Location *	LS
Category	Earthen Levee			GPS Latitude/Longitude	
				Start	End
Item	Vegetation			38.285188 °	38.285143 °
				-121.795334 °	-121.777128 °
DWR ID	DWR_RD2060_02_f_2018_6				
Comment Code					
V1 : Control annual grass and weeds on the levee slopes and easements.					
Inspector Comment					
Maintain vegetation on land side slope

View of vegetation on land side slope (October 2018)

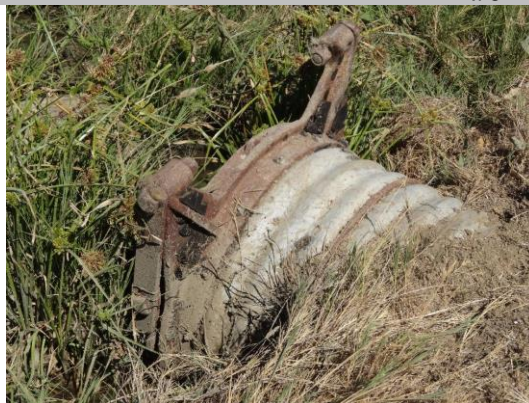
Photo 2 of 3 : UCIP_SP_2019_18386_30872.jpg

Comment Code						
Inspector Comment						
FS_ID:18386 DS_ID:22056 EP_NO: 10148 Repair Type: Non-Urgent Crossing Status: Found UCIP Comments: U-type concrete headwall on LS. Not accessible due to fence.Vegetation is partially blocking inlet & outlet pipe. FIELD_STRUCT_DESC: 24-inch corrugated metal gravity drainage pipe through the levee, 16 feet below the crown. Flap gate on the waterside (WS) end. Concrete U-shaped headwall on the landside (LS) end. Not accessible due to a fence. Vegetation is partially blocking the inlet and the outlet of the pipe. (24-inch drainage pipe through the levee and a flap gate retained under Automatic Board Order (ABO) issued as Permit No. 10148, 1974 - Reclamation District No. 2060, care of G. T. Wyatt). [Additional Reference(s): DWR Levee Log, 2005]. FS Date: 8/15/2013

WS view: CM pipe with flap gate. Not accessible. Vegetation is partially blocking outlet pipe.

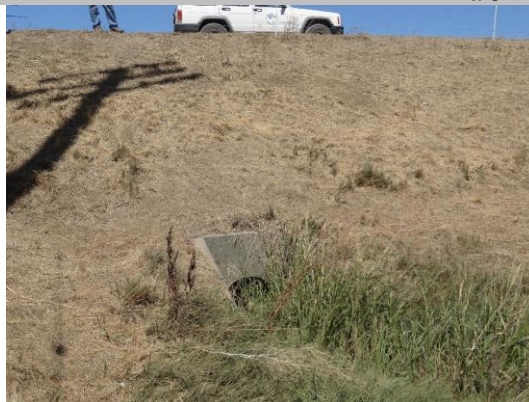
Photo 3 of 3 : UCIP_SP_2019_18386_30874.jpg

LS view: CM pipe with U shaped concrete headwall. Not accessible. Vegetation is partially blocking inlet pipe.

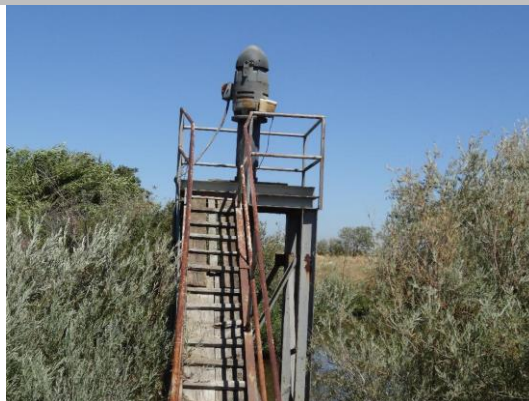
Photo 2 of 3 : UCIP_SP_2019_41668_31160.jpg

Comment Code						
Inspector Comment						
FS_ID:41668 DS_ID:22060 EP_NO: 5927 Repair Type: Non-Urgent Crossing Status: Found UCIP Comments: verify pipe has been abandoned properly. - abandoned pump and pipe.- electrical box on WS shoulder. FIELD_STRUCT_DESC: *ABANDONED* 18-inch steel irrigation discharge pipe through the levee, 4 feet below the crown. Corrugated metal cutoff wall. Pump on a piling structure on the riverbank. Siphon breaker on the landside (LS) slope. Concrete distribution box and irrigation ditch at the LS toe. (To relocate an existing irrigation pumping plant and discharge pipe through the levee authorized under Permit No. 5927, 1967 - Cache Slough Pheasant Hunting Preserve, Inc., care of Downey, Brand, Seymour, and Rohwer, Attorneys at Law). [Additional Reference(s): DWR Levee Log, 2005]. FS Date: 8/15/2013

WS view: pump on pile structure with stairs on bank.

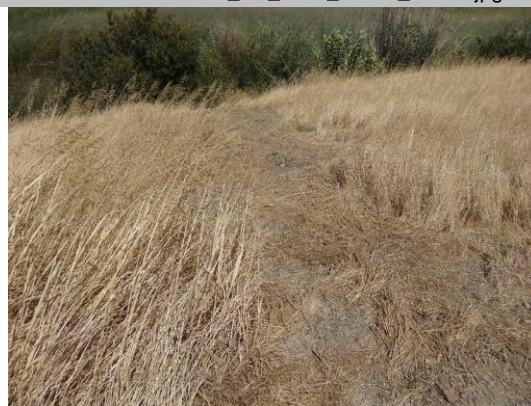
Photo 1 of 2 : UCIP_SP_2019_18727_31317.jpg

LM Start	0.90	Rating **	M	Issue No.	72
LM End	0.90	Issue Type +	En	Location *	
Category	Supplemental			GPS Latitude/Longitude	
				Start	End
Item	DWR UCIP Field Study			38.290684 °	38.290684 °
				-121.735668 °	-121.735668 °
DWR ID	22067				
Comment Code					
Inspector Comment					
FS_ID:18727 DS_ID:22067 EP_NO: N/A Repair Type: Non-Urgent Crossing Status: Found UCIP Comments: Seem abandoned.Not found- pump on LS. Needs more exploration. FIELD_STRUCT_DESC: 6-inch steel irrigation discharge pipe through the levee, 2.8 feet below the crown. Pump on the landside (LS). Gate valve on the waterside (WS). [Additional Reference(s): USACE Sacramento O&M Manual 107, April 1959, (HLM 0.4), 10-inch pipe referenced]. FS Date: 8/15/2013

Waterside view: levee slope.

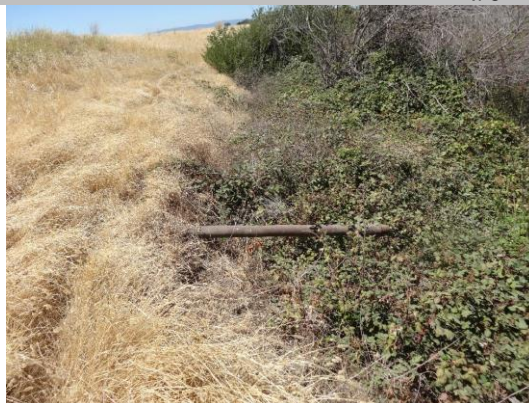
Photo 2 of 2 : UCIP_SP_2019_18727_31316.jpg

LM Start	0.90	Rating **	M	Issue No.	72 (cont)	
LM End	0.90	Issue Type +	En	Location *		
Category	Supplemental			GPS Latitude/Longitude		
				Start	End	
Item	DWR UCIP Field Study			38.290684 °	38.290684 °	
				-121.735668 °	-121.735668 °	
DWR ID	22067					
Comment Code						
Inspector Comment						
FS_ID:18727 DS_ID:22067 EP_NO: N/A Repair Type: Non-Urgent Crossing Status: Found UCIP Comments: Seem abandoned.Not found- pump on LS. Needs more exploration. FIELD_STRUCT_DESC: 6-inch steel irrigation discharge pipe through the levee, 2.8 feet below the crown. Pump on the landside (LS). Gate valve on the waterside (WS). [Additional Reference(s): USACE Sacramento O&M Manual 107, April 1959, (HLM 0.4), 10-inch pipe referenced]. FS Date: 8/15/2013

Waterside view: levee slope and a steel pipe.

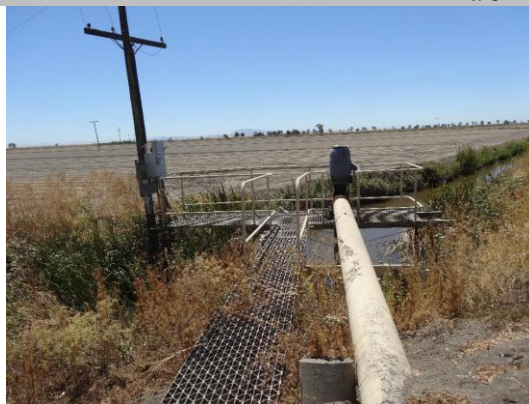
Photo 1 of 3 : UCIP_SP_2019_18726_31314.jpg

Comment Code					
Inspector Comment					
FS_ID:18726 DS_ID:22063 EP_NO: 6342 Repair Type: Non-Urgent Crossing Status: Found UCIP Comments: Leaky siphon breaker may need to be repaired. Dense vegetation on WS.Not found- gate valve on LS. FIELD_STRUCT_DESC: 16-inch coated steel drainage discharge pipe through the levee, 8 feet below the crown. Vertical pump in drainage ditch on the landside (LS). Gate valve on the LS. Siphon breaker on the waterside (WS). (Plans to replace a 10-inch drainage pipe through the levee authorized under Permit No. 6342, 1968 - Hastings Farms. Plans to revise plans by changing pipe size from 10-inch to 16-inch through the levee authorized under Permit No. 6342-A, 1971 - Hastings Farms). FS Date: 8/15/2013

Landside view: pump, service pole, steel support structure, walkway, and pipe.

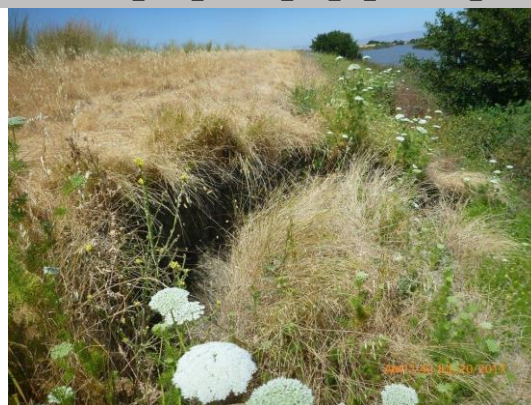
Photo 1 of 3 : SP_2019_RD2060_243_20_20190311_00016.jpg

LM Start	1.21	Rating **	M	Issue No.	20
LM End	1.23	Issue Type +	Ma	Location *	
Category	Supplemental			GPS Latitude/Longitude	
				Start	End
Item	2017 Storm Damage			38.290511 °	38.290486 °
				-121.729867 °	-121.729603 °
DWR ID	DWR_RD2060_03_f_2017_20				
Comment Code					
Inspector Comment					
Levee Evaluation Comments					
Description:Erosion commences 1/4 of the way down the slope with slippage towards the water side toe.					
Site ID No:390					
Site Designation:LMA-217					
Repair Type: Erosion					
Rating:Area of Concern					
Field Date:7/20/2017					
Notes: Erosion halfway down WS slope. Monitor for progression.

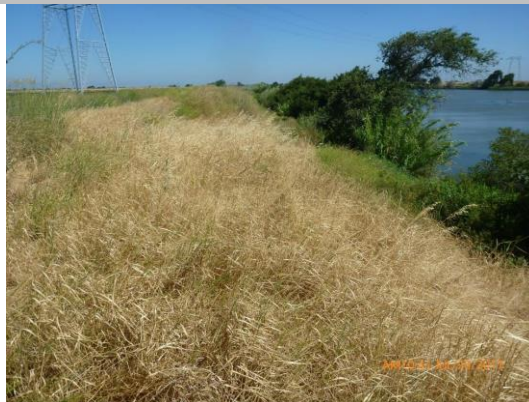
Photo 1 of 3 : SP_2019_RD2060_243_23_20190311_00025.jpg

LM Start	1.62	Rating **	A/W	Issue No.	23	
LM End	1.63	Issue Type +	Ma	Location *		
Category	Supplemental			GPS Latitude/Longitude		
				Start	End	
Item	2017 Storm Damage			38.287336 °	38.287222 °	
				-121.724364 °	-121.724253 °	
DWR ID	DWR_RD2060_03_f_2017_23					
Comment Code						
Inspector Comment						
Levee Evaluation Comments						
Description:Erosion commences halfway down the slope and results in slippage into the waterside toe. Existing rip rap has sloughed into the water side toe.						
Site ID No:393						
Site Designation:LMA-220						
Repair Type: Erosion						
Rating:Serious						
Field Date:7/20/2017						
Notes: Moderate sloughing 8ft from WS crown. Erosion at high water mark.

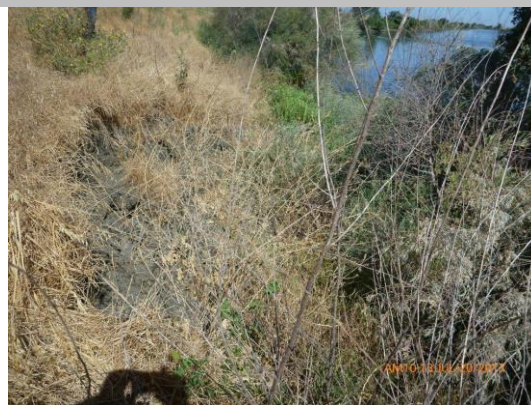
Photo 1 of 3 : SP_2019_RD2060_243_25_20190311_00028.jpg

LM Start	1.84	Rating **	M	Issue No.	25
LM End	1.92	Issue Type +	Ma	Location *	
Category	Supplemental			GPS Latitude/Longitude	
				Start	End
Item	2017 Storm Damage			38.284825 °	38.284467 °
				-121.721764 °	-121.720339 °
DWR ID	DWR_RD2060_03_f_2017_25				
Comment Code					
Inspector Comment					
Levee Evaluation Comments					
Description:Erosion commences halfway down the slope and results in					
slippage into the waterside toe.					
Site ID No:395					
Site Designation:LMA-222					
Repair Type: Erosion					
Rating:Area of Concern					
Field Date:7/20/2017					
Notes: Erosion halfway down slope. Monitor for progression.

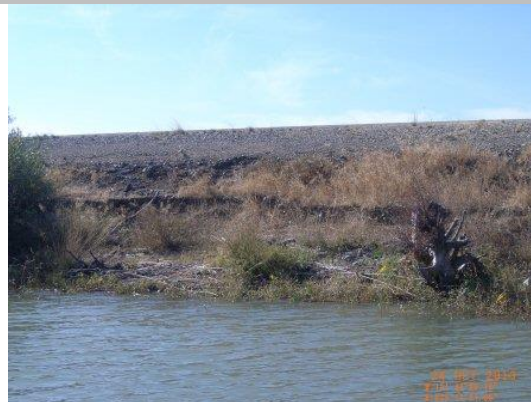
Photo 1 of 1 : SP_2019_RD2060_243_6_20190311_00002.jpg

LM Start	2.02	Rating **	A/W	Issue No.	6
LM End	2.08	Issue Type +	Ma	Location *	WS
Category	Supplemental			GPS Latitude/Longitude	
				Start	End
Item	2017 USACE Erosion Survey, DRAFT			38.284105 °	38.283302 °
				-121.718471 °	-121.717814 °
DWR ID	DWR_RD2060_03_f_2018_6				
Comment Code					
Inspector Comment					
2017 Site ID: CHS 23.0 R					
Status: Eroding					
2017 Field Notes: No observed changes.					
Site History: 2010 - Small maintenance site.

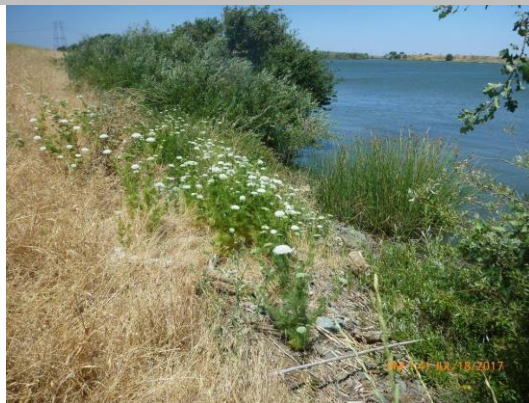
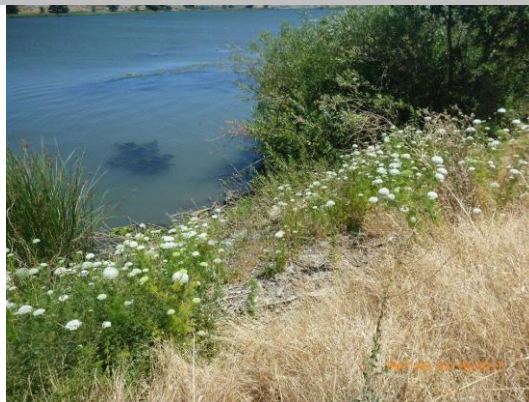
LM Start	2.02	Rating **	M	Issue No.	26
LM End	2.06	Issue Type +	Ma	Location *	
Category	Supplemental			GPS Latitude/Longitude	
				Start	End
Item	2017 Storm Damage			38.283914 °	38.283422 °
				-121.718614 °	-121.718206 °
DWR ID	DWR_RD2060_03_f_2017_26				
Comment Code					
Inspector Comment					
Levee Evaluation Comments					
Description:Erosion commences halfway down the slope and results in slippage into the waterside toe. Existing rip rap has sloughed into the water side toe.					
Site ID No:396					
Site Designation:LMA-223					
Repair Type: Erosion					
Rating:Area of Concern					
Field Date:7/18/2017					
Notes: Erosion to high water line.

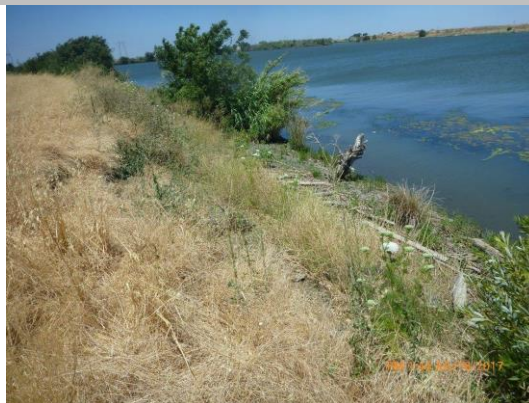
Photo 3 of 3 : SP_2019_RD2060_243_26_20190311_00033.jpg

LM Start	2.02	Rating **	M	Issue No.	26 (cont)	
LM End	2.06	Issue Type +	Ma	Location *		
Category	Supplemental			GPS Latitude/Longitude		
				Start	End	
Item	2017 Storm Damage			38.283914 °	38.283422 °	
				-121.718614 °	-121.718206 °	
DWR ID	DWR_RD2060_03_f_2017_26					
Comment Code						
Inspector Comment						
Levee Evaluation Comments						
Description:Erosion commences halfway down the slope and results in slippage into the waterside toe. Existing rip rap has sloughed into the water side toe.						
Site ID No:396						
Site Designation:LMA-223						
Repair Type: Erosion						
Rating:Area of Concern						
Field Date:7/18/2017						
Notes: Erosion to high water line.

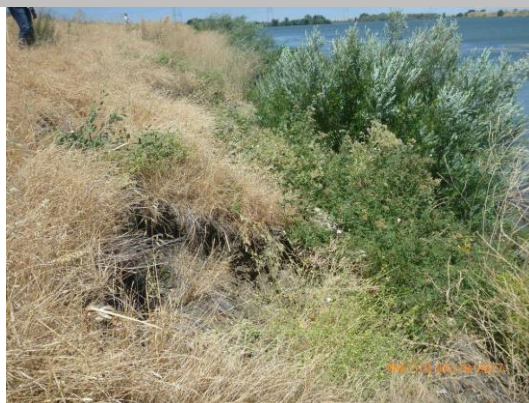
Photo 1 of 3 : SP_2019_RD2060_243_27_20190311_00034.jpg

LM Start	2.12	Rating **	A/W	Issue No.	27
LM End	2.15	Issue Type +	Ma	Location *	
Category	Supplemental			GPS Latitude/Longitude	
				Start	End
Item	2017 Storm Damage			38.282733 °	38.282403 °
				-121.717683 °	-121.717428 °
DWR ID	DWR_RD2060_03_f_2017_27				
Comment Code					
Inspector Comment					
Levee Evaluation Comments					
Description:Erosion commences approximately 1/4 of the way down the slope and results in slippage into the waterside toe.					
Site ID No:397					
Site Designation:LMA-224					
Repair Type: Erosion					
Rating:Serious					
Field Date:7/18/2017					
Notes: Benched erosion with large cracks on slope above. Light veg in erosion.

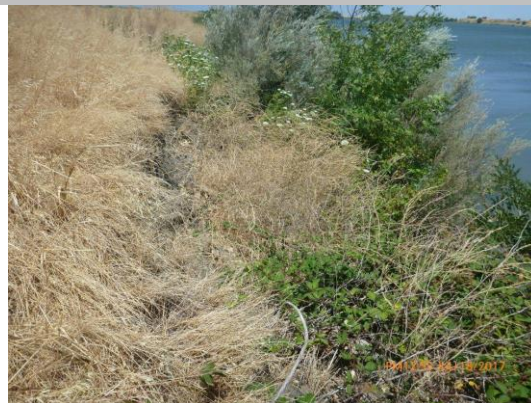
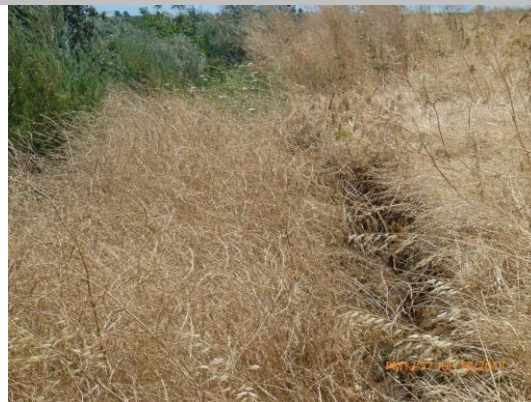
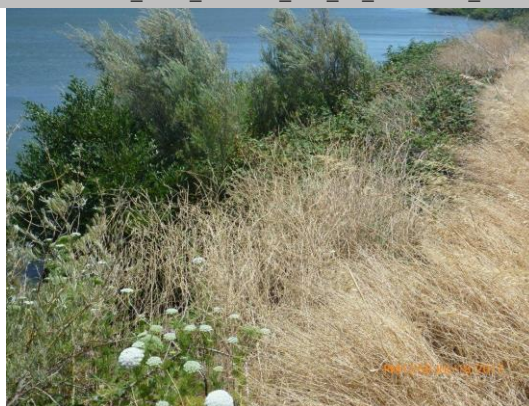
LM Start	2.19	Rating **	A/W	Issue No.	28
LM End	2.22	Issue Type +	Ma	Location *	
Category	Supplemental			GPS Latitude/Longitude	
				Start	End
Item	2017 Storm Damage			38.281839 °	38.281486 °
				-121.716964 °	-121.716661 °
DWR ID	DWR_RD2060_03_f_2017_28				
Comment Code					
Inspector Comment					
Levee Evaluation Comments					
Description:Erosion commences approximately 1/4 of the way down the slope and results in slippage into the waterside toe.					
Site ID No:398					
Site Designation:LMA-225					
Repair Type: Erosion					
Rating:Serious					
Field Date:7/18/2017					
Notes: Erosion is near vertical with light veg. Existing rip rap to the left of site.

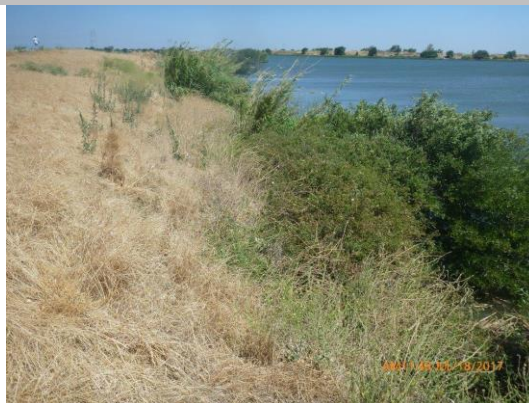
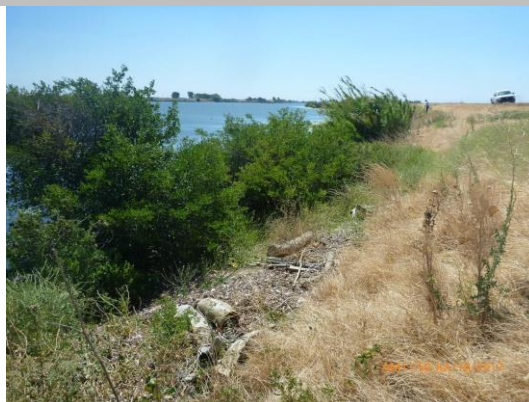
LM Start	2.36	Rating **	M	Issue No.	31
LM End	2.43	Issue Type +	Ma	Location *	
Category	Supplemental			GPS Latitude/Longitude	
				Start	End
Item	2017 Storm Damage			38.280208 °	38.279336 °
				-121.714853 °	-121.714172 °
DWR ID	DWR_RD2060_03_f _ 2017_31				
Comment Code					
Inspector Comment					
Levee Evaluation Comments					
Description:Erosion commences approximately halfway down the slope and results in slippage into the waterside toe.					
Site ID No:400					
Site Designation:LMA-227					
Repair Type: Erosion					
Rating:Area of Concern					
Field Date:7/18/2017					
Notes: Steep cut but protected with heavy woody veg.

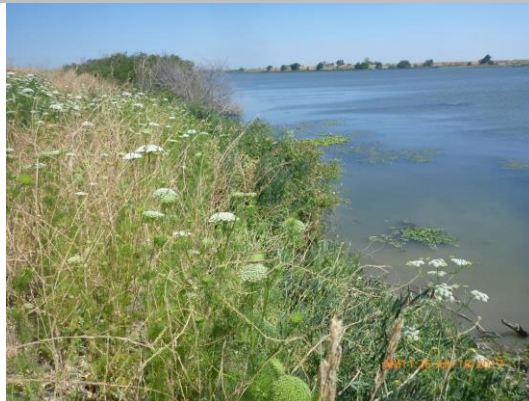
LM Start	2.47	Rating **	M	Issue No.	32 (cont)
LM End	2.49	Issue Type +	Ma	Location *	
Category	Supplemental			GPS Latitude/Longitude	
				Start	End
Item	2017 Storm Damage			38.278794 °	38.278533 °
				-121.713703 °	-121.713453 °
DWR ID	DWR_RD2060_03_f _ 2017_32				
Comment Code					
Inspector Comment					
Levee Evaluation Comments					
Description:Erosion commences approximately halfway down the slope and results in sloughing into the waterside toe.					
Site ID No:401					
Site Designation:LMA-228					
Repair Type: Erosion					
Rating:Area of Concern					
Field Date:7/18/2017					
Notes: Erosion and sloughing. Heavy veg flanking both sides.

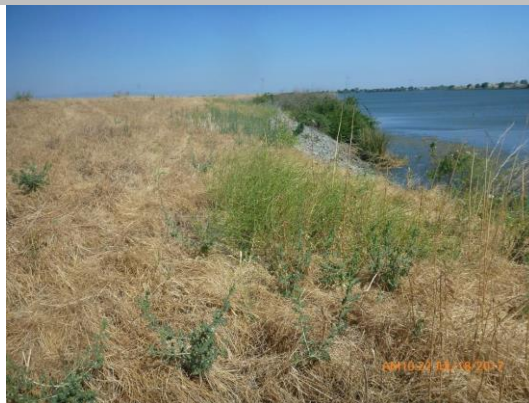
Photo 3 of 3 : SP_2019_RD2060_243_35_20190311_00057.jpg

LM Start	2.64	Rating **	M	Issue No.	35 (cont)	
LM End	2.64	Issue Type +	Ma	Location *		
Category	Supplemental			GPS Latitude/Longitude		
				Start	End	
Item	2017 Storm Damage			38.277106 °	38.277078 °	
				-121.711489 °	-121.711447 °	
DWR ID	DWR_RD2060_03_f _ 2017_35					
Comment Code						
Inspector Comment						
Levee Evaluation Comments						
Description:Erosion commences approximately 1/4 of the way down the slope and results in sloughing into the waterside toe.						
Site ID No:404						
Site Designation:LMA-231						
Repair Type: Erosion						
Rating:Area of Concern						
Field Date:7/18/2017						
Notes: Small erosion and sloughing adjacent to revetted slope.

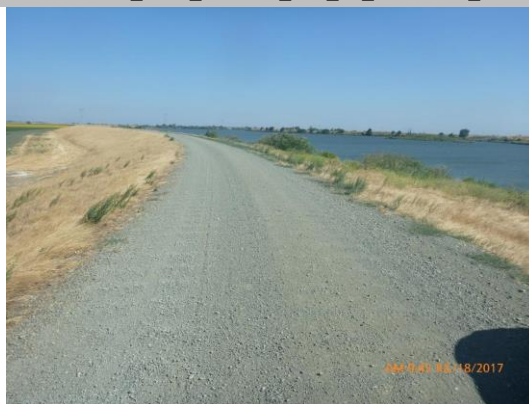
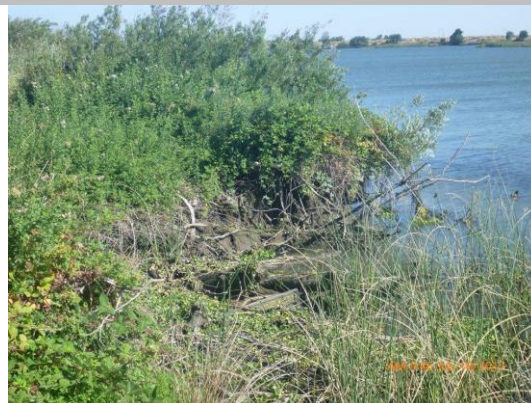
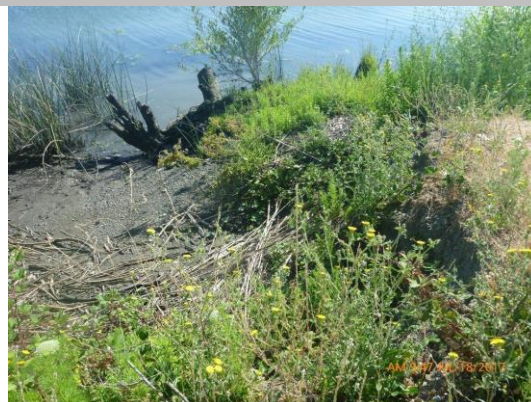
LM Start	2.69	Rating **	A/W	Issue No.	36
LM End	2.73	Issue Type +	Ma	Location *	
Category	Supplemental			GPS Latitude/Longitude	
				Start	End
Item	2017 Storm Damage			38.276608 °	38.276133 °
				-121.710811 °	-121.710394 °
DWR ID	DWR_RD2060_03_f_2017_36				
Comment Code					
Inspector Comment					
Levee Evaluation Comments					
Description:Sloughing commences approximately halfway down the slope and extends to the waterside toe.					
Site ID No:405					
Site Designation:LMA-232					
Repair Type: Erosion					
Rating:Serious					
Field Date:7/18/2017					
Notes: Vertical cut at highwater mark.

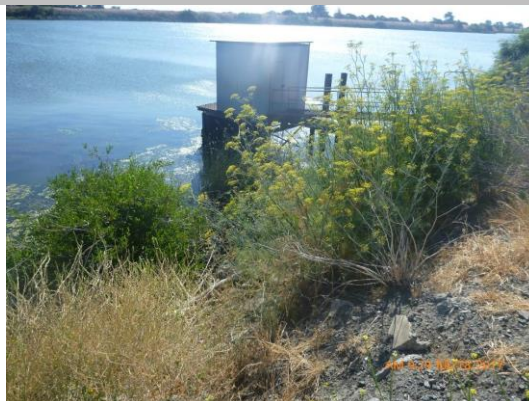
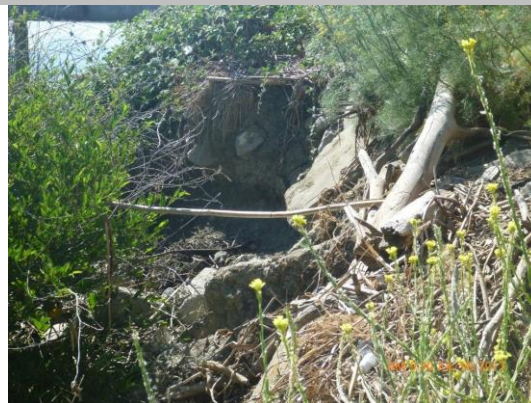
LM Start	3.24	Rating **	M	Issue No.	37
LM End	3.24	Issue Type +	Ma	Location *	
Category	Supplemental			GPS Latitude/Longitude	
				Start	End
Item	2017 Storm Damage			38.270231 °	38.270203 °
				-121.705897 °	-121.705856 °
DWR ID	DWR_RD2060_03_f_2017_37				
Comment Code					
Inspector Comment					
Levee Evaluation Comments					
Description:Erosion commences approximately halfway down the slope and results in sloughing into the waterside toe. Existing rip rap has been pulled off the slope at this site.					
Site ID No:406					
Site Designation:LMA-233					
Repair Type: Erosion					
Rating:Area of Concern					
Field Date:7/18/2017					
Notes: Erosion is next to a pumphouse and slope is protected withrip rap.

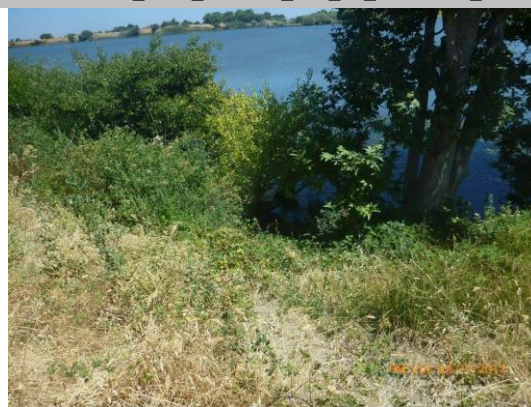
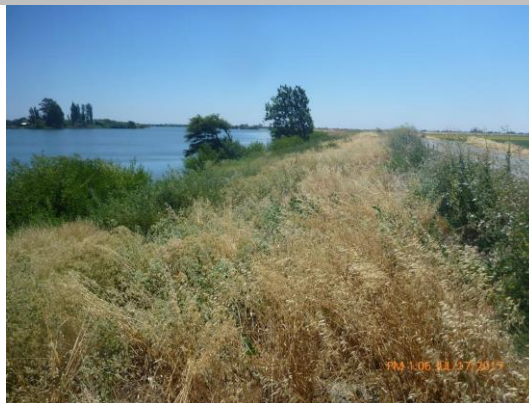
LM Start	3.82	Rating **	A/W	Issue No.	40
LM End	3.94	Issue Type +	Ma	Location *	
Category	Supplemental			GPS Latitude/Longitude	
				Start	End
Item	2017 Storm Damage			38.264006 °	38.262364 °
				-121.698811 °	-121.698103 °
DWR ID	DWR_RD2060_03_f _ 2017_40				
Comment Code					
Inspector Comment					
Levee Evaluation Comments					
Description:Erosion commences approximately halfway down the slope and results in sloughing into the waterside toe. Existing rip rap has been pulled off the slope at this site					
Site ID No:410					
Site Designation:LMA-237					
Repair Type: Erosion					
Rating:Serious					
Field Date:7/18/2017					
Notes: This site is combined with LMA-234. There is minor toe erosion along whole 631 lf, but there is a 20' wide deep erosion at 38.26347, -121.69859. That is the only location that is serious and is likely due toa collapsed beaver den.

Comment Code						
Inspector Comment						
Levee Evaluation Comments						
Description:Erosion commences approximately halfway down the slope and results in sloughing into the waterside toe. Existing rip rap has been pulled off the slope at this site						
Site ID No:410						
Site Designation:LMA-237						
Repair Type: Erosion						
Rating:Serious						
Field Date:7/18/2017						
Notes: This site is combined with LMA-234. There is minor toe erosion along whole 631 lf, but there is a 20' wide deep erosion at 38.26347, -121.69859. That is the only location that is serious and is likely due toa collapsed beaver den.

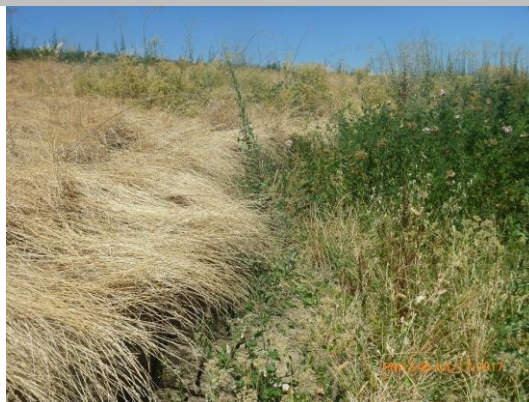
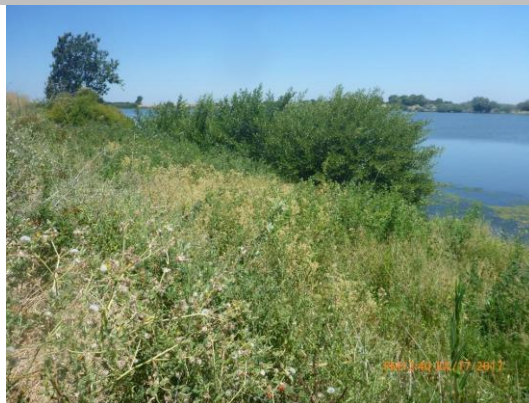
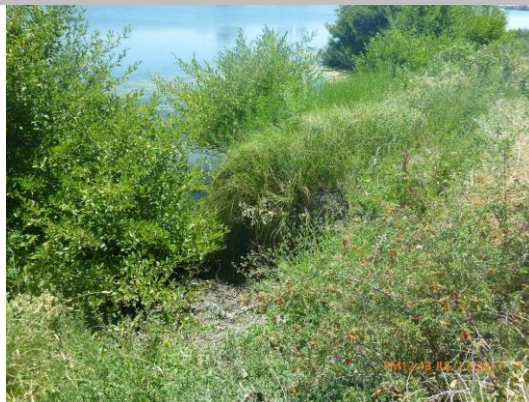
LM Start	3.96	Rating **	A/W	Issue No.	41
LM End	4.00	Issue Type +	Ma	Location *	
Category	Supplemental			GPS Latitude/Longitude	
				Start	End
Item	2017 Storm Damage			38.262114 °	38.261583 °
				-121.697978 °	-121.697647 °
DWR ID	DWR_RD2060_03_f_2017_41				
Comment Code					
Inspector Comment					
Levee Evaluation Comments					
Description:Erosion commences approximately halfway down the slope and results in sloughing into the waterside toe.					
Site ID No:411					
Site Designation:LMA-238					
Repair Type: Erosion					
Rating:Serious					
Field Date:7/18/2017					
Notes: This site includes LMA-235. Wide erosion looks like several small sited merged. Heavy veg indicates slow erosion.

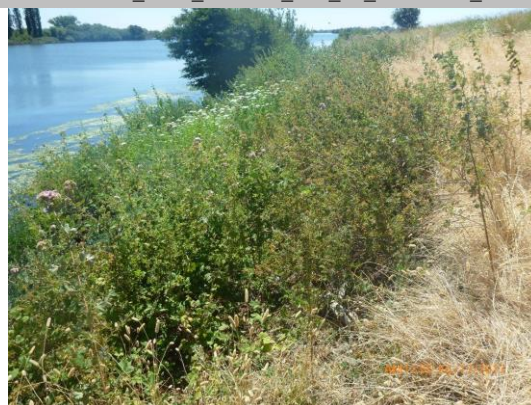
LM Start	4.06	Rating **	A/W	Issue No.	42 (cont)
LM End	4.08	Issue Type +	Ma	Location *

LM Start	4.06	Rating **	A/W	Issue No.	42
LM End	4.08	Issue Type +	Ma	Location *	
Category	Supplemental			GPS Latitude/Longitude	
				Start	End
Item	2017 Storm Damage			38.260789 °	38.260644 °
				-121.696964 °	-121.696828 °
DWR ID	DWR_RD2060_03_f _ 2017_42				
Comment Code					
Inspector Comment					
Levee Evaluation Comments					
Description:Erosion commences approximately halfway down the slope and results in sloughing into the waterside toe. Existing rip rap has been pulled off the slope at this site.					
Site ID No:412					
Site Designation:LMA-239					
Repair Type: Erosion					
Rating:Serious					
Field Date:7/17/2017					
Notes: Small erosion. Appears that site grows slowly with each high water. The center of the eosion is a deep cut that extends below rhe waterline. Possible beaver den collapse.
